Manhole Inspection Summary

Manhole # S31SS_039MH

Location Address: **2806 HUNTINGDON AVE**

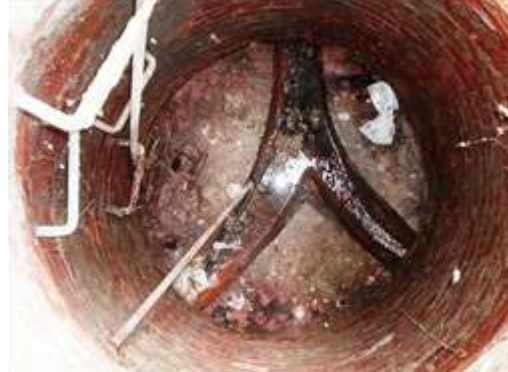
Top View

Corroded steps. Evidence of surcharge - Bench debris. Channel debris.

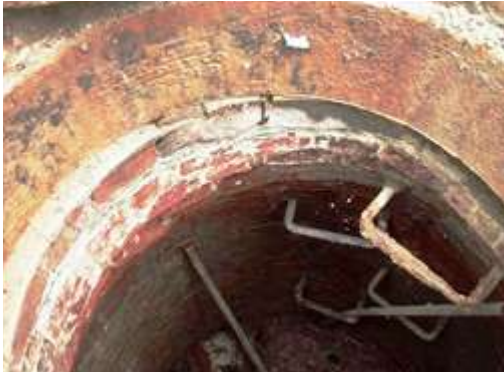
Defect

Adjustment deterioration and infiltration. Corbel and Barrel infiltration - other side.

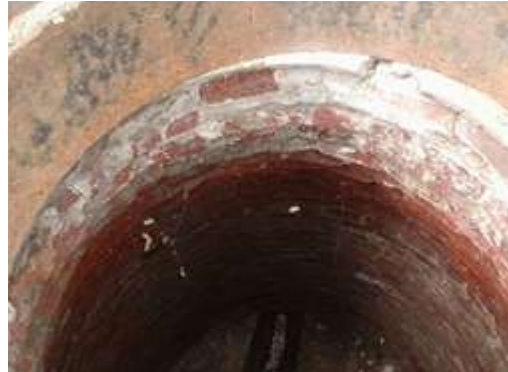
Defect

Adjustment deterioration and infiltration. Corbel and Barrel infiltration.

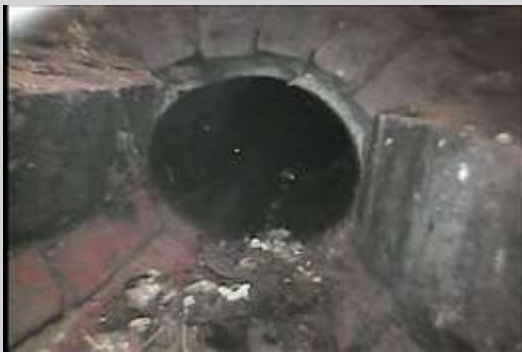
8 in. Circular Gravity Sewer Pipe Out @ 12 O'Clock

Deposits: ☐ None ☒ **Mud** ☐ Sludge ☒ **Debris** ☐ Grease

Infiltration: **Evidence** Pipe Seal Cond: **Cracked**

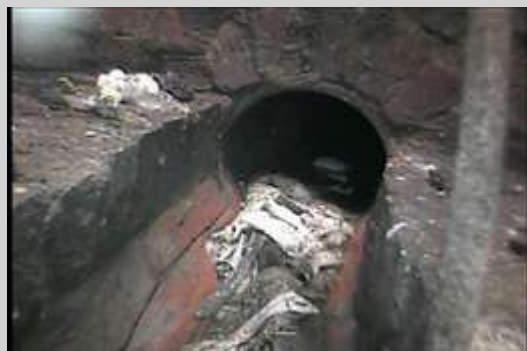
Pipe In @ 7 O'Clock

Channel deterioration and debris.

Deposits: ☐ None ☒ **Mud** ☐ Sludge ☒ **Debris** ☐ Grease
